210 Ft Advanced Antenna System
Report on Hydrostatic Bearing Damage

8 November 1965

HYDROSTATIC BEARING
RUNNER DAMAGE LAYOUT

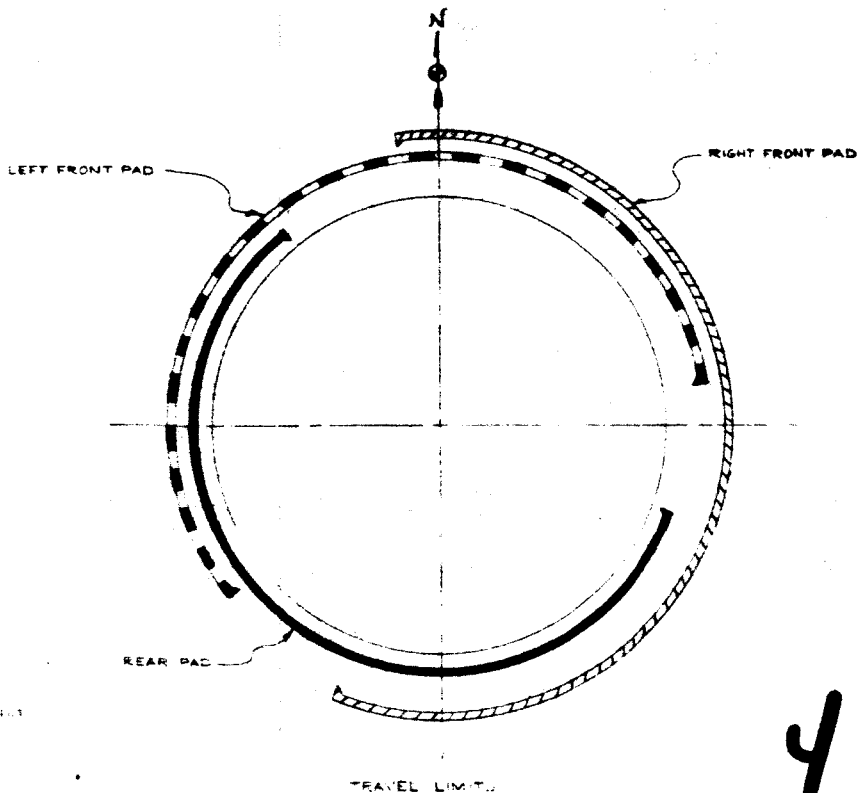
Figure 1

- On 24 and 25 August in connection with placing the feed cone, the antenna was rotated counter clockwise from position four through position five to position six (Figure 1). During this motion the anti-rotation link, because the motion was in the opposite direction of that going from position two to position four, probably cleared the dragging corner of the rear pad causing little or no damage to the runner.

- On 30 August the antenna was moved clockwise from position six to position seven, and then on 2 September to position eight where the final damage occurred. (See Appendix I for detailed description of events at this time). During this motion the rear pad inner right corner apparently was again dragging, causing small scratches as previously described until it reached the 5 o'clock position on Figure 1, when the scratching changed to galling (Figures 6, 7, and 8). The galling continued until the pad was in about the 10 o'clock position (Figures 9 and 10). At this point first one lump then a second lump of metal were ejected from behind the pad, apparently relieving the galling so that no further serious damage was done by the rear pad during the balance of the motion to position eight. In the meantime the right pad encountered the crests of the gall marks left by the rear pad in the 5 to 6 o'clock section of the runner. These "cutting and abrading tools" caused severe damage over the entire length of the pad and finally resulted in so much rotational movement that the torque link, which normally restrains such rotation, was broken.

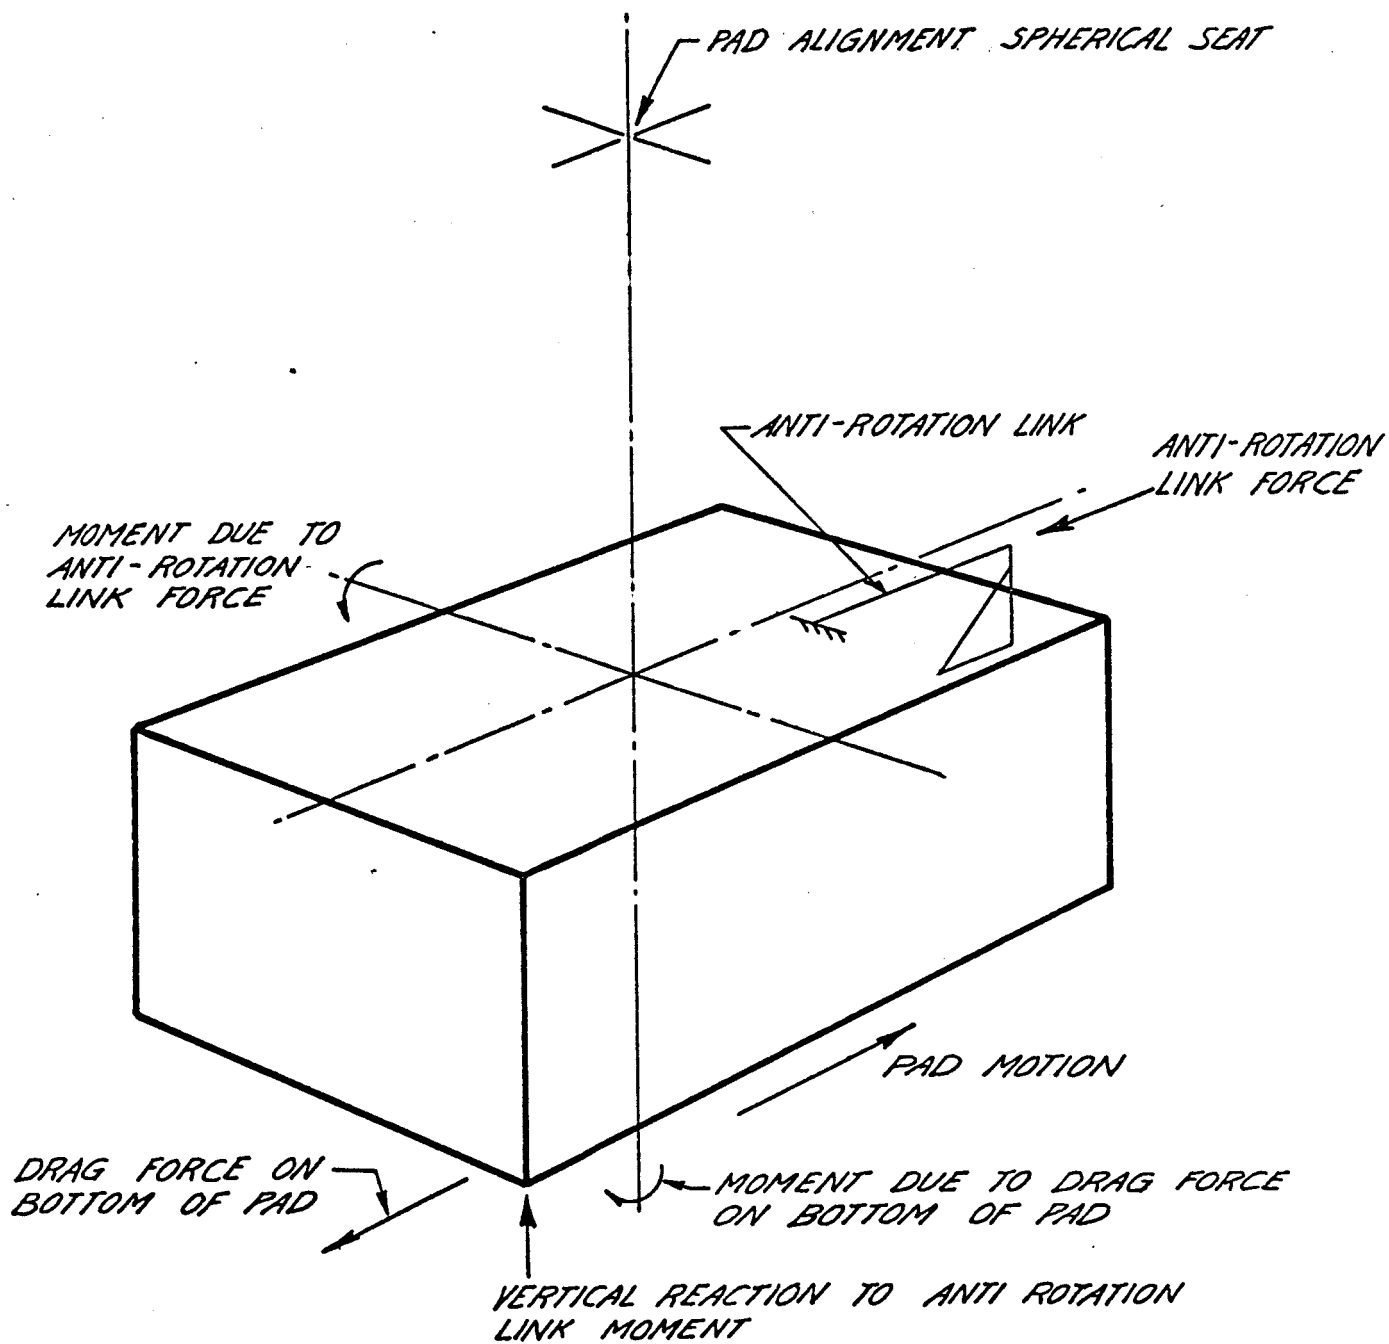
FIGURE 2
ANTI - ROTATION LINK ACTION

As far as the intensity and the pattern of the failure is concerned, it is obvious that the pad constraint mechanism (the mechanism that prevents the pad from rotating about a vertical axis) aggravated the situation by driving one of the pad edges down onto the runner. The fact that this was a design error was known to all concerned before the failure. To alleviate the feeling of regret for not having modified this feature it can be observed that, unless the constraint mechanism started the galling process, the failure would have progressed to the point of giving obvious hints such as smoke, sound, etc. Therefore, the constraint mechanism may only be responsible for accelerating the failure but not for causing it.

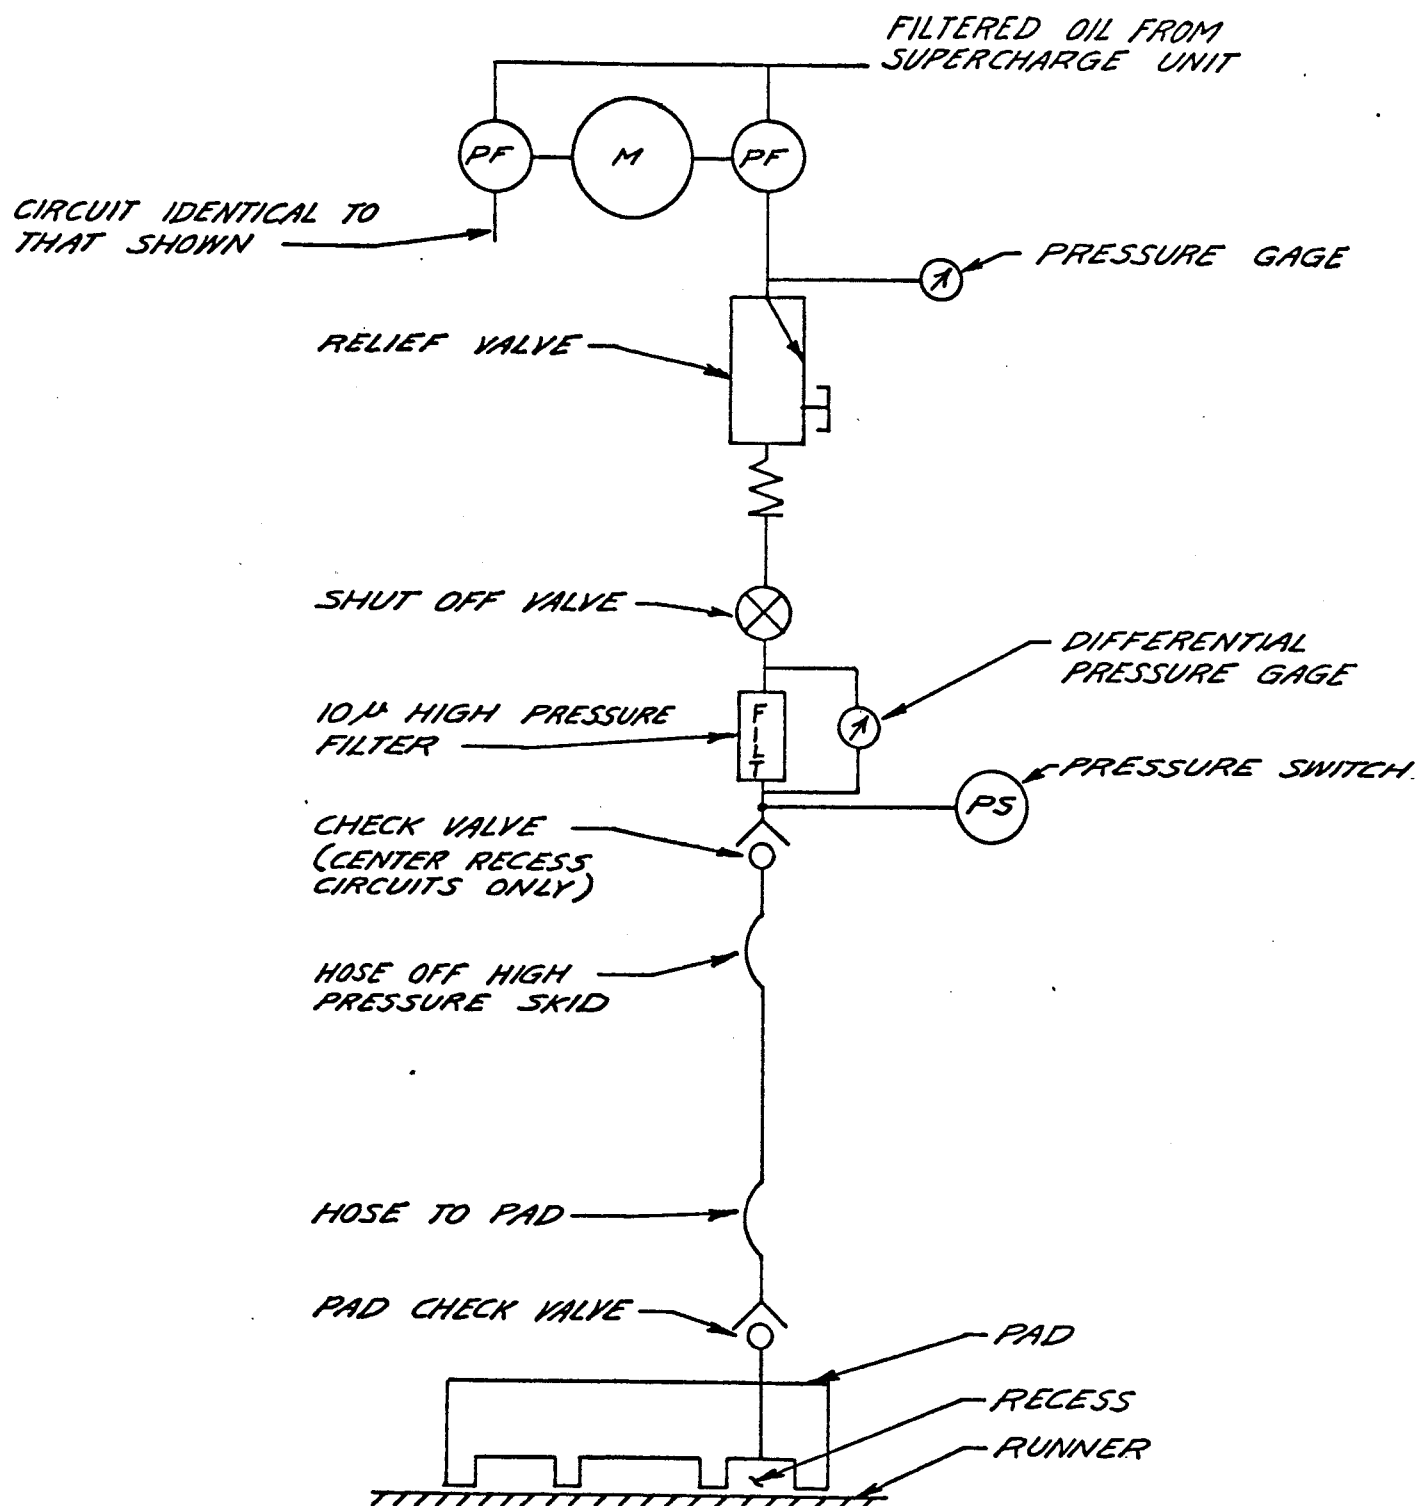
FIGURE 3
 HYDROSTATIC BEARING HIGH PRESSURE
 CIRCUIT

The high pressure supply system for each recess consists of an electric motor driving a constant displacement pump, a pressure relief valve, a shut-off valve, a high pressure filter, piping and hoses to the pad. A check valve at the pad entry serves to prevent flow from the pad back into the lines in the event of line breakage or pump shutdown; this is shown schematically in Figure 3. The definite or possible contributions of each of these elements to the failure is discussed below:

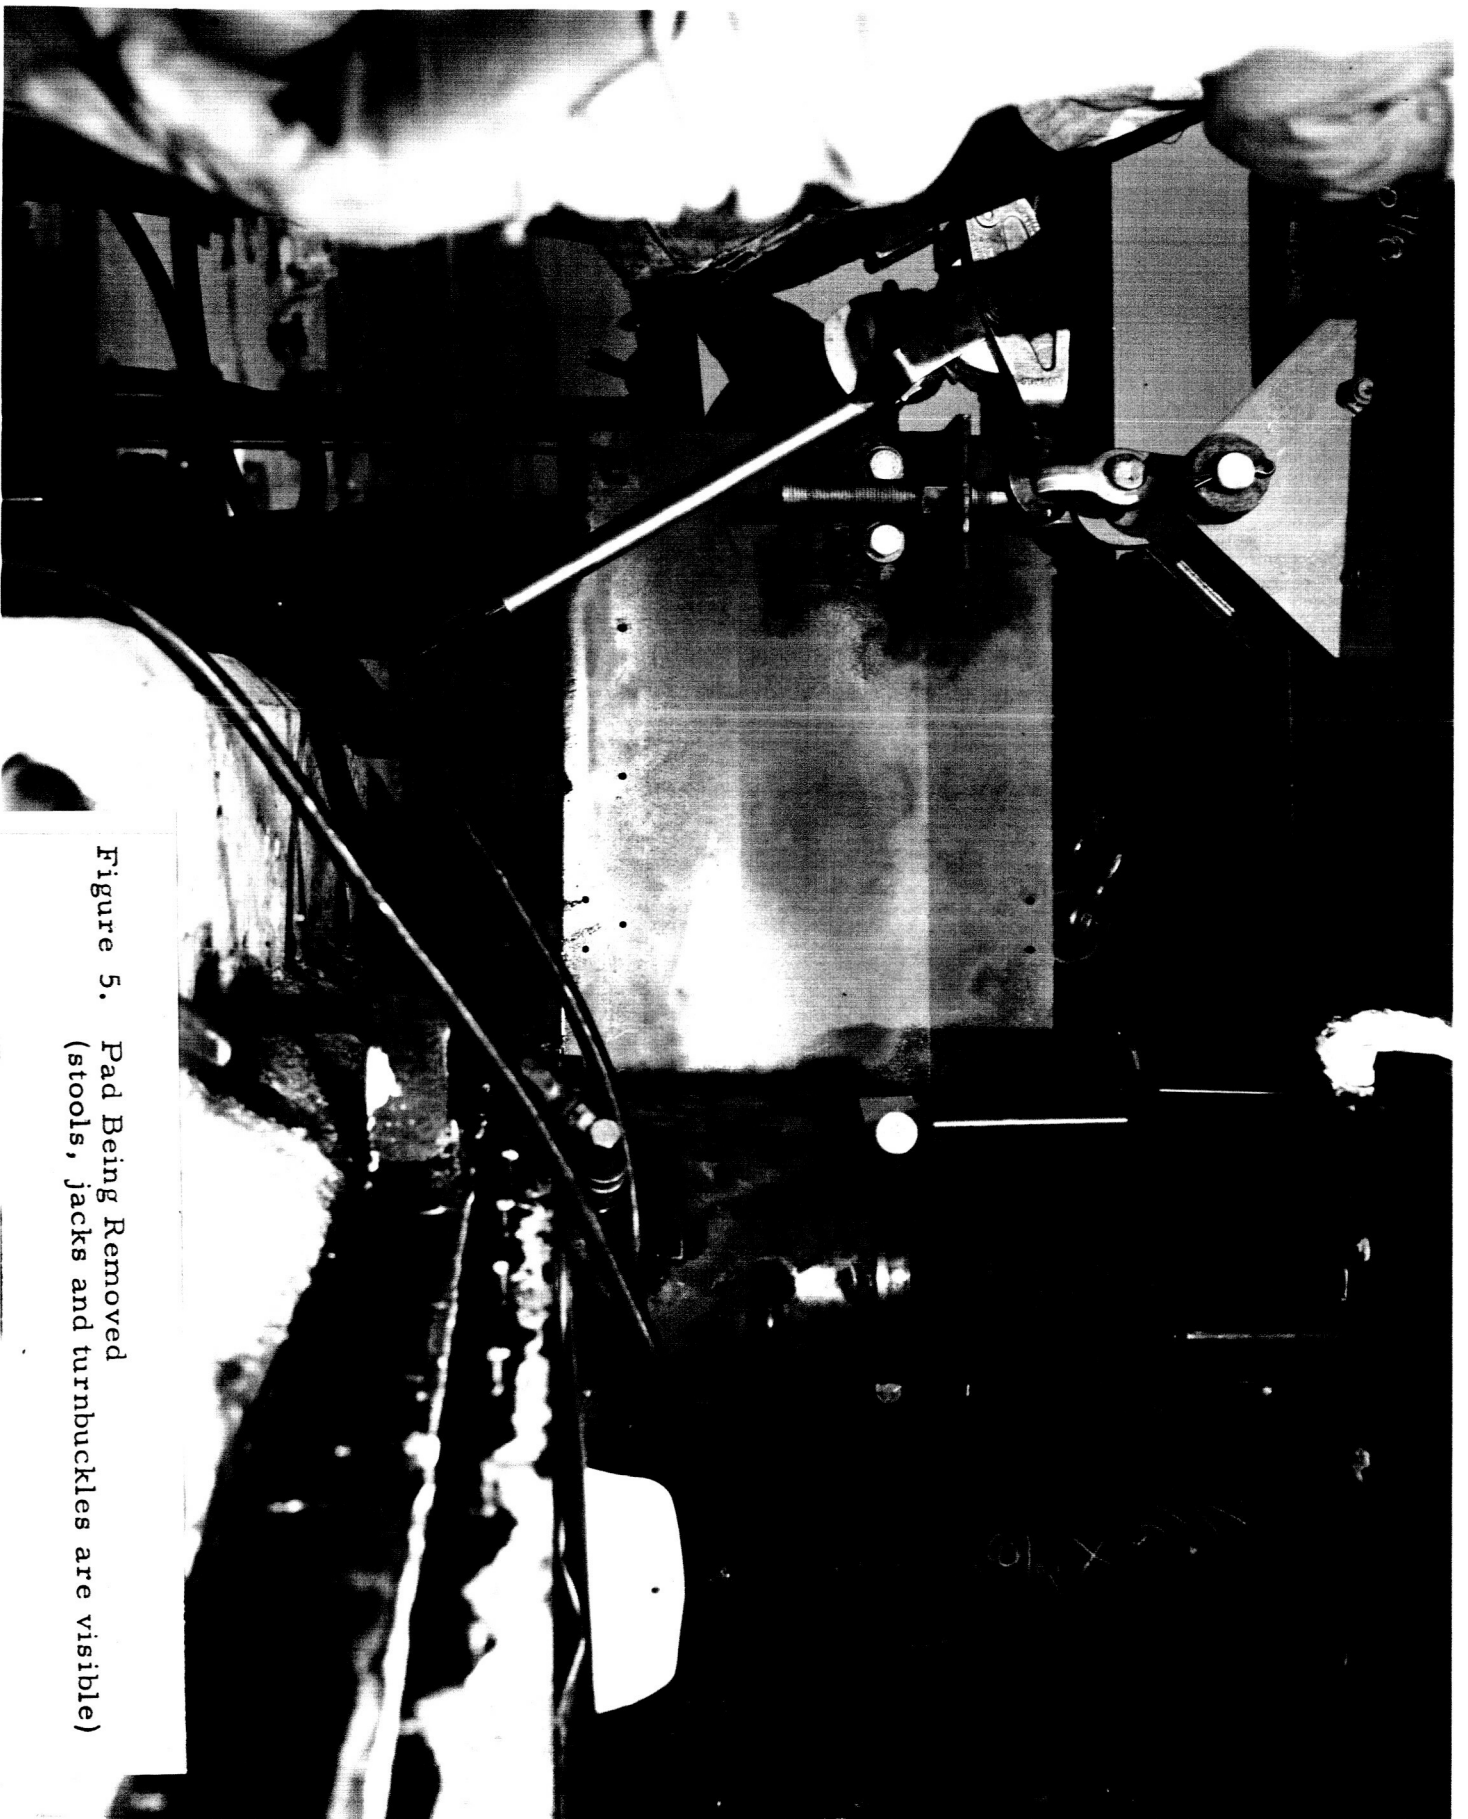
Figure 5. Pad Being Removed
(stools, jacks and turnbuckles are visible)

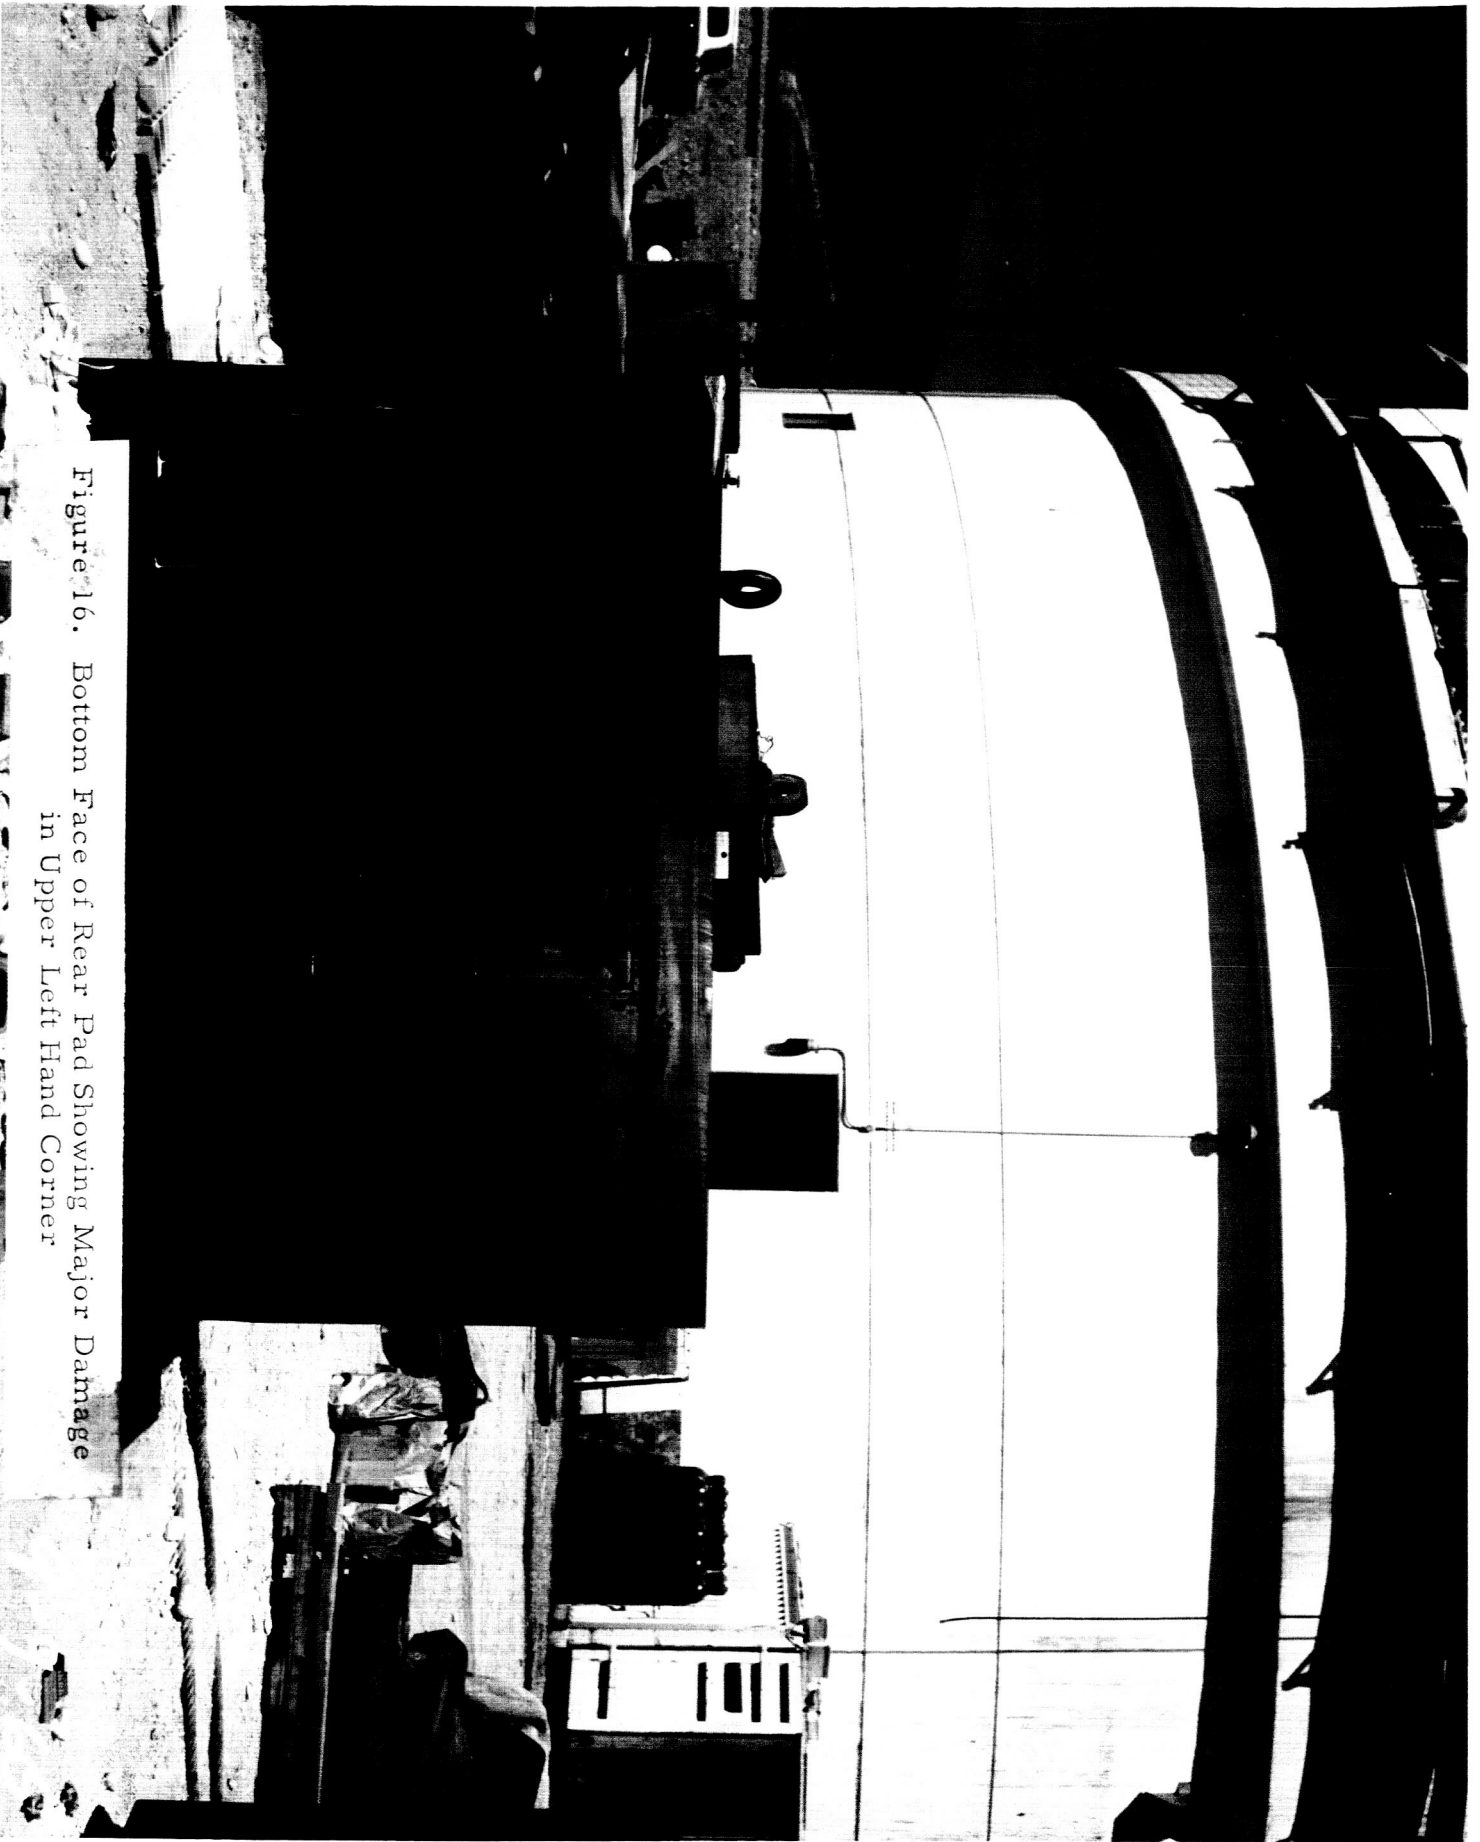
Figure 16. Bottom Face of Rear Pad Showing Major Damage
in Upper Left Hand Corner

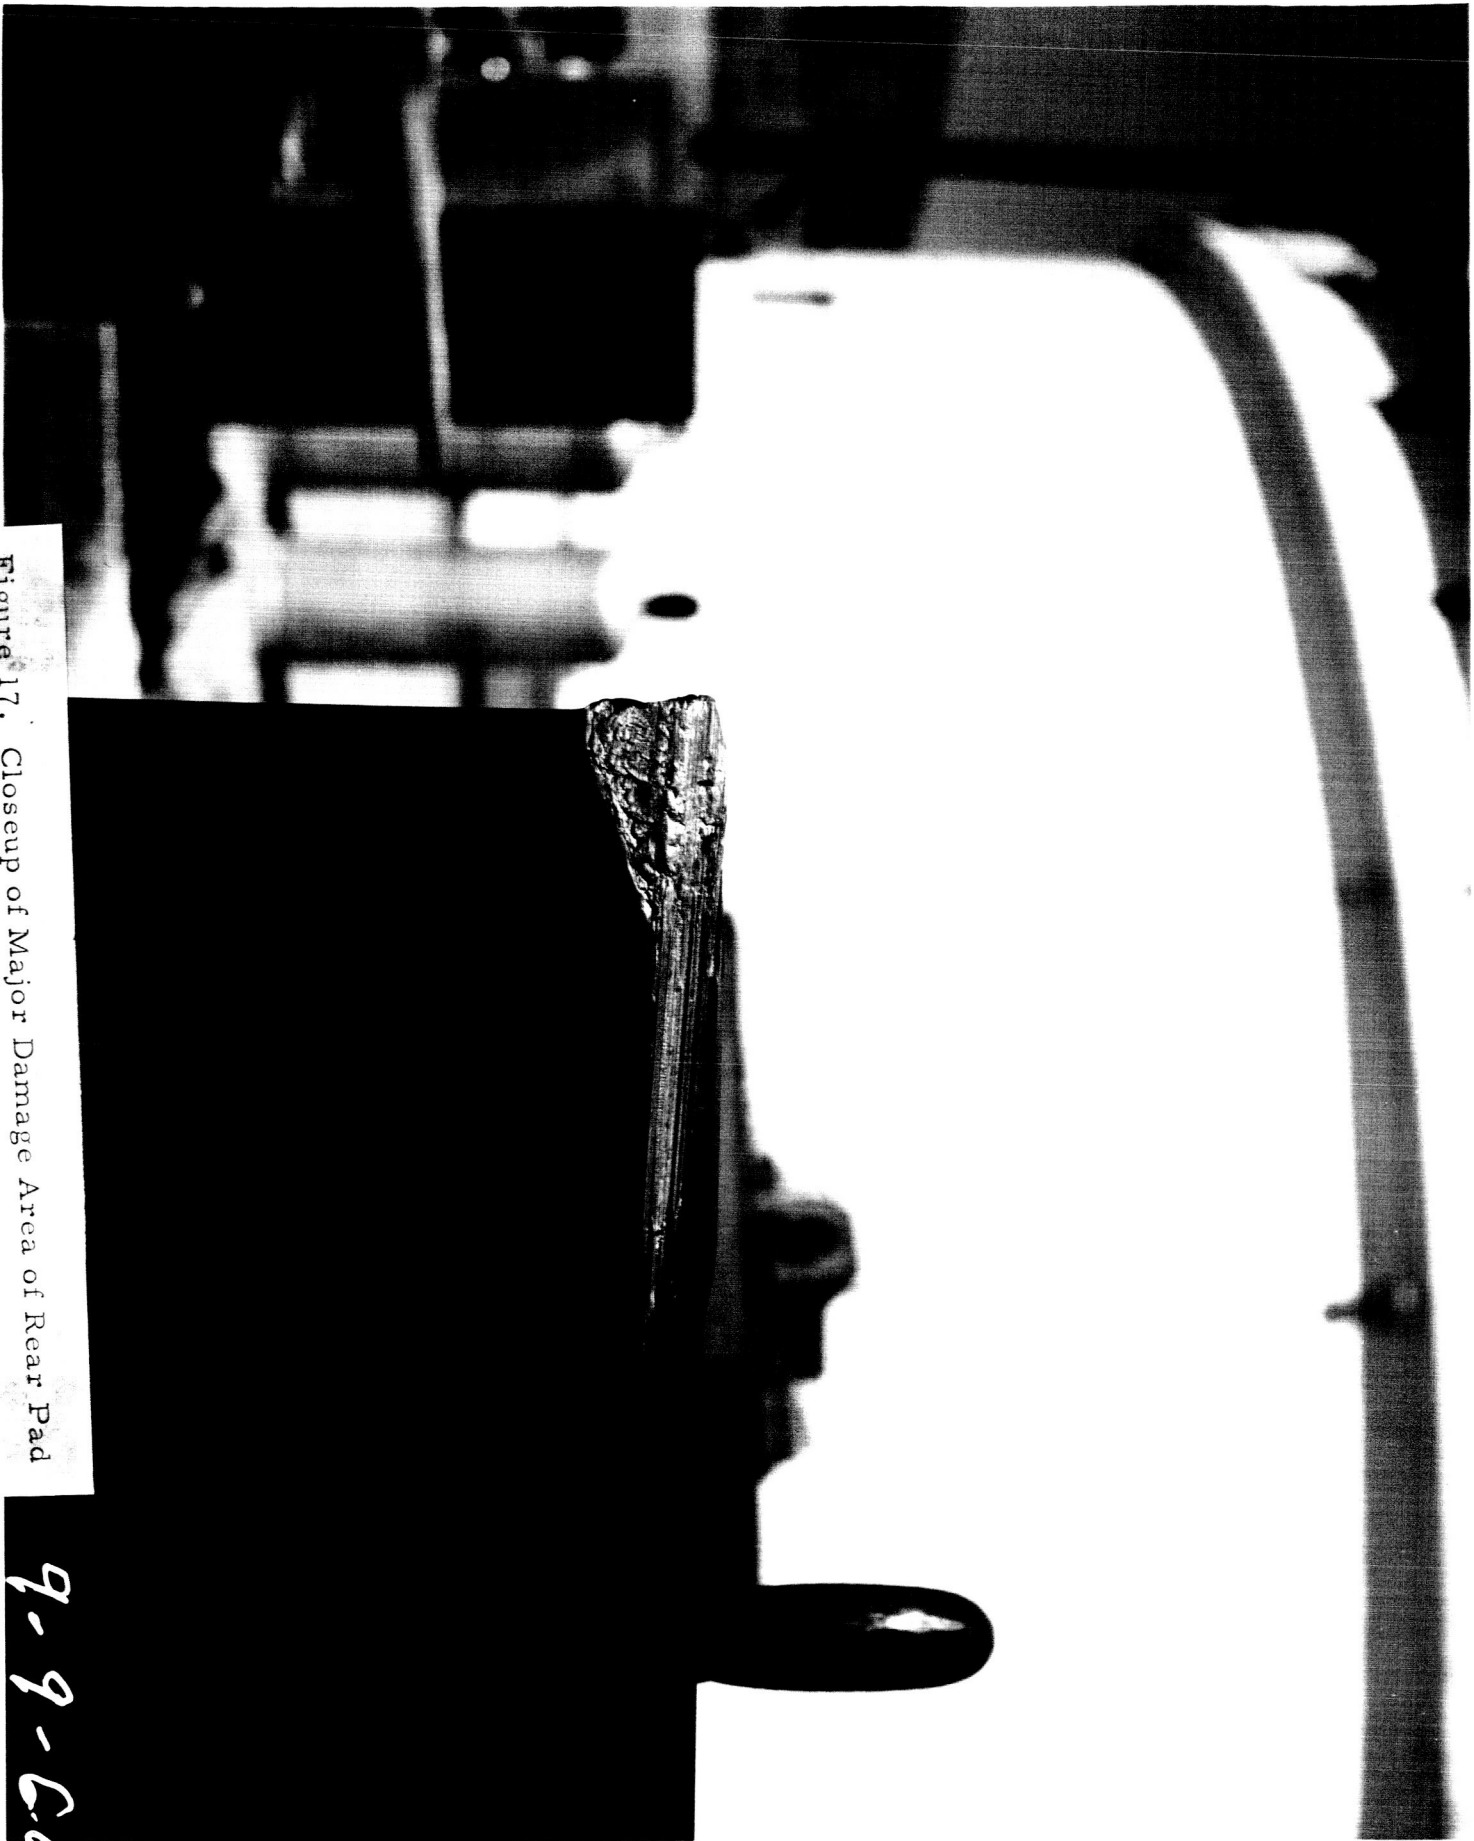
Figure 17. Closeup of Major Damage Area of Rear Pad

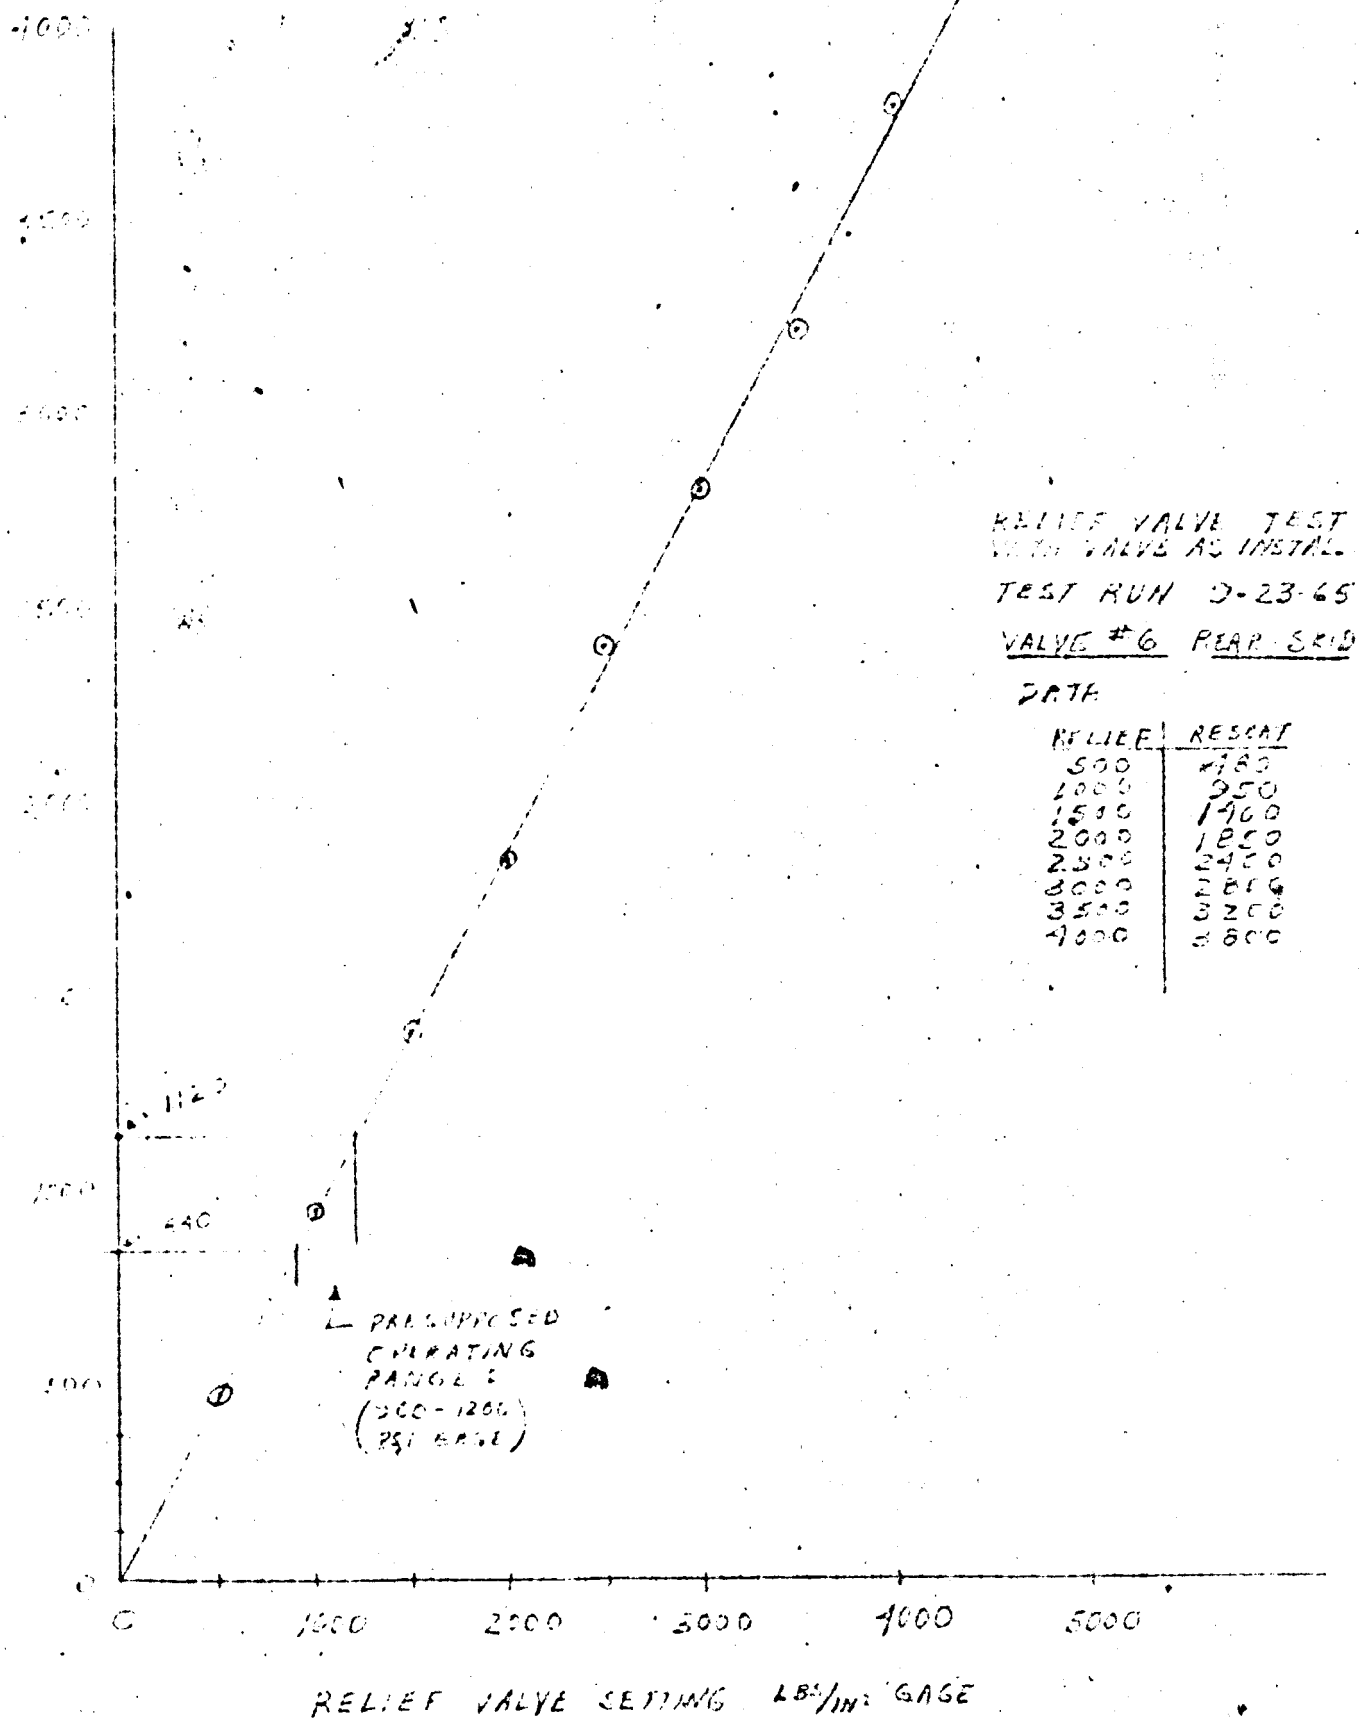
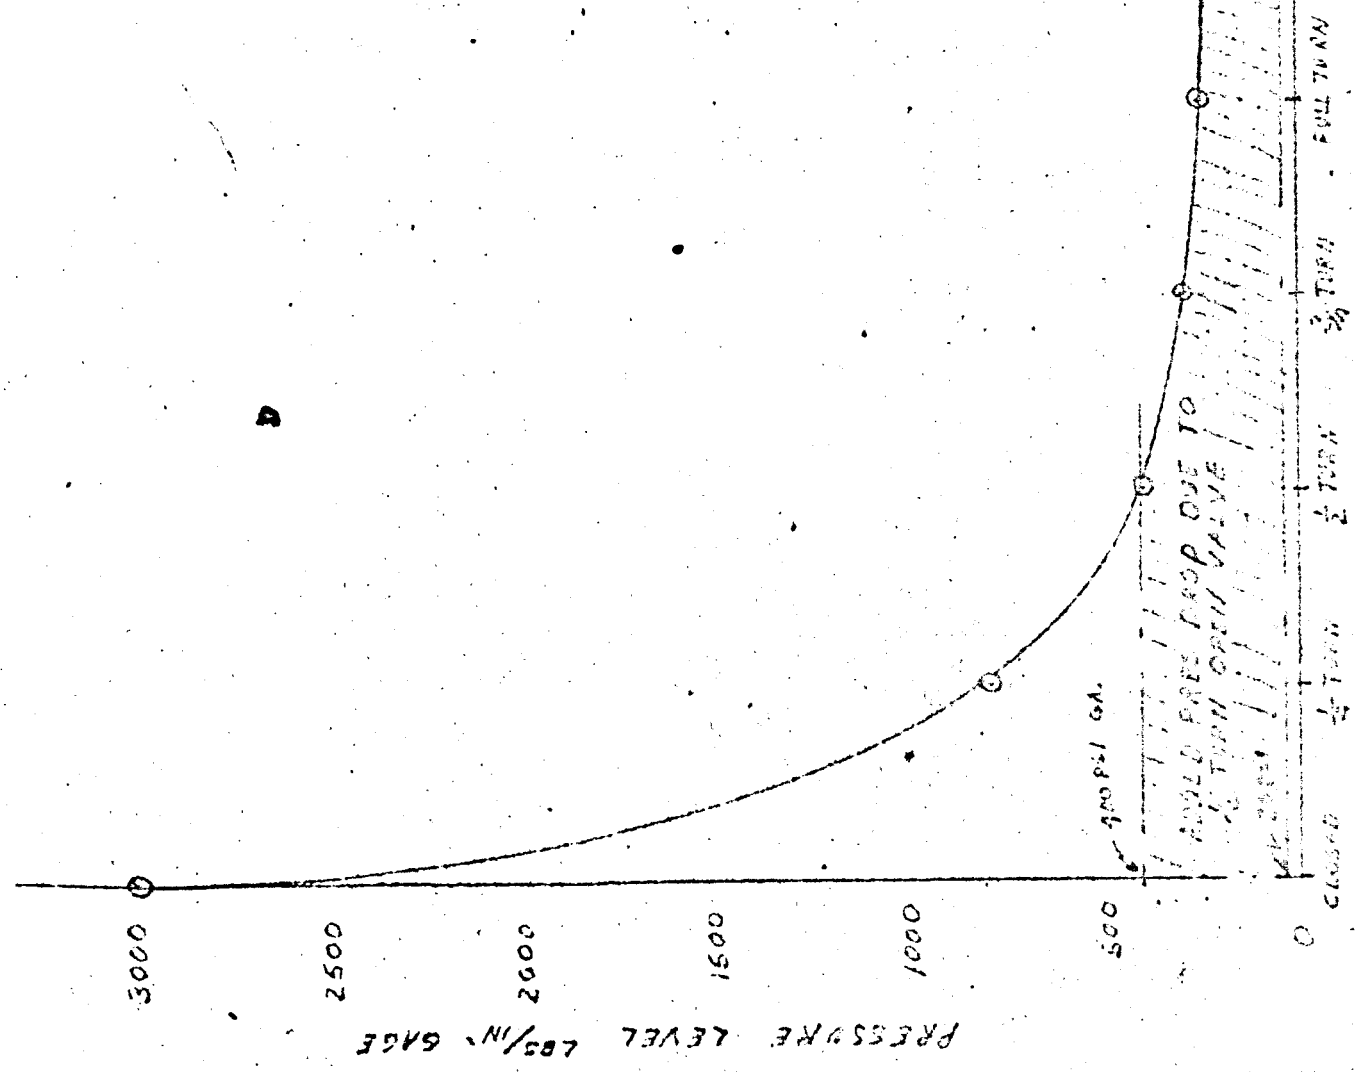
FIGURE 4

After the accident it was found that several of the shutoff valves downstream of the relief valve were partially closed. Tests run on the valves in the field indicate that the pressure drop across these valves as set was in the order of 200 to 300 psi for the full flow of oil through them. In this condition they would tend to cause the pressure relief valves to function at a lower recess pressure than if they were fully open, and hence increase the chance of the triggering relief valve acting as a pressure regulator, or constant pressure source.

SHUT OFF VALVE TEST
VALVE #2 REAR SKID

VALVE POS.	PRES. PSIG.
CLOSED	3000 (RELIEF SETTING)
1/4 TURN	800
1/2 TURN	400
3/4 TURN	300
FULL TURN	250
FULL OPEN	20 (ESTIMATED)
